NATIONAL AUDIT OFFICE OF THE GAMBIA

PERFORMANCE AUDIT REPORT

**THE PROVISION OF WATER IN URBAN, PERI-URBAN AND
PROVINCIAL GROWTH CENTRES BY NAWEC**

NOVEMBER 2022

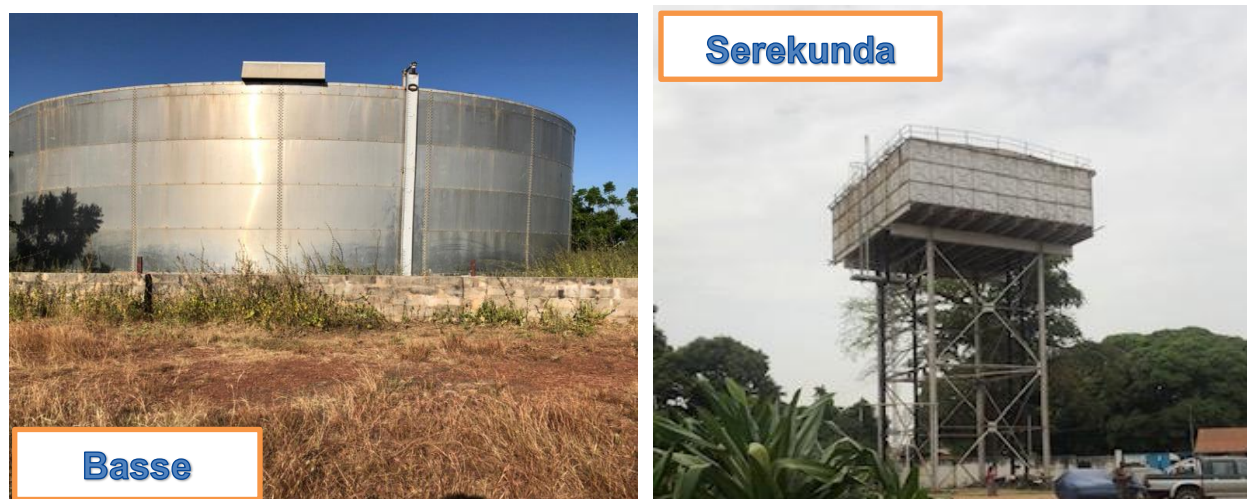
As shown in table 3 above, 44% of the elevated tanks were bypassed due to the excess demand, faulty liners, structural problems, and old age. Some of these causes were corroborated by the water and sanitation in the Greater Banjul Area (WASIB) project feasibility study. Picture 1 shows the non-functional elevated tanks at Basse and Serekunda water treatment plants.

Picture 1: Non-functional water tank at Basse water facility and Serekunda Treatment Plant

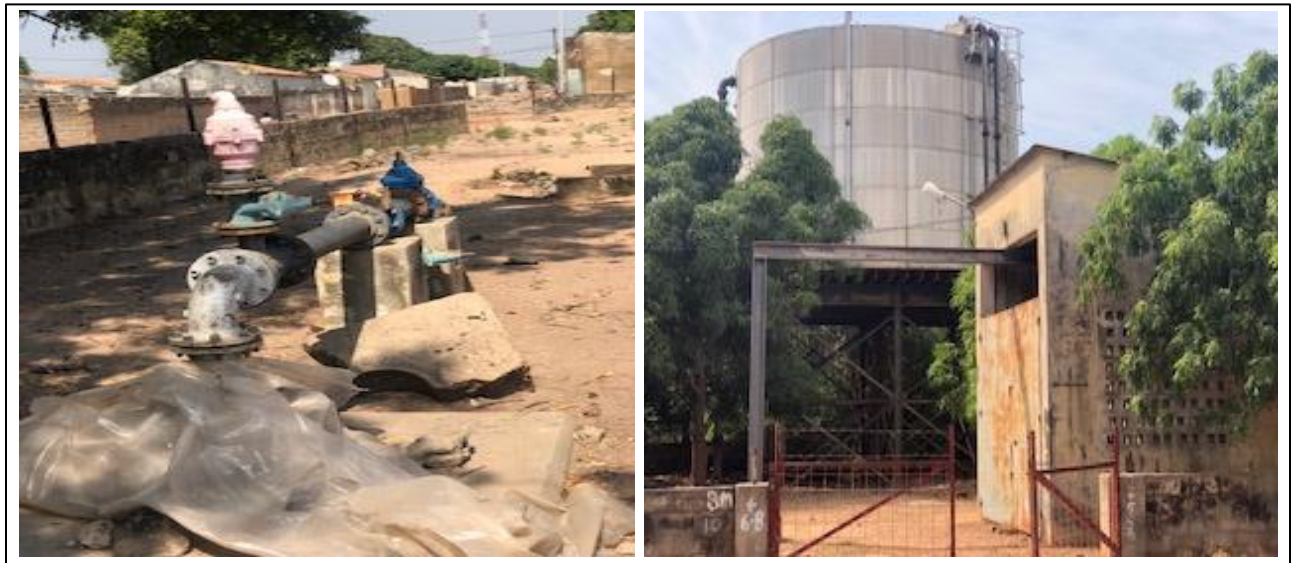
Picture 2: The unprotected water facility at Farafenni (Left) and Mansakonko water facility (right)

Furthermore, during site visits, we found that some of the older boreholes had their copper cables exposed to theft and/or vandalism. NAWEC has started burying these cables in new boreholes but has failed to do the same for the older ones. Consequently, people continue to cause damages to these cables that resulted in hours of no water production. For instance, NAWEC has recently announced that four (4) other boreholes in Latriya and Jambur were vandalized in 2021 by cutting the copper cables and rendering them non-operational²⁷. In addition, it reported that three (3) boreholes in Brikama Forest were vandalized in 2018 by cutting off their cable causing the company to lose 4.5 million liters of water per day²⁸.

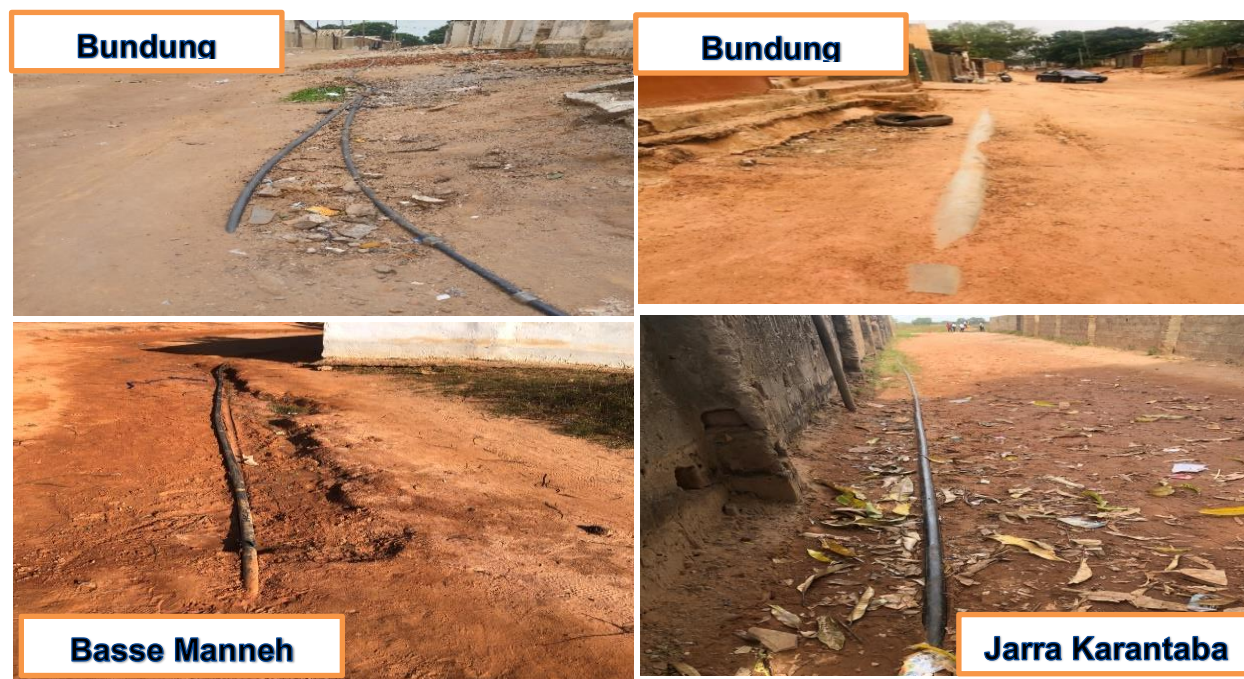
Picture 4: NAWEC's exposed distribution pipe (top Left), main pipe (top right) in Bundung and exposed distribution pipe (Bottom left) exposed distribution pipe at Jarra Karantaba (Bottom right)

NAWEC's Water Division Management informed us that the exposure is sometimes caused by soil erosion, or the pipes were not laid at the appropriate depth during installation. This assertion was confirmed during our site visits as seen in the above pictures (3 and 4) that pipes were not properly buried as required. In addition, during an interview, the management of Water Division acknowledged that NAWEC has not set up a monitoring team to follow up on its ground works.⁴⁰

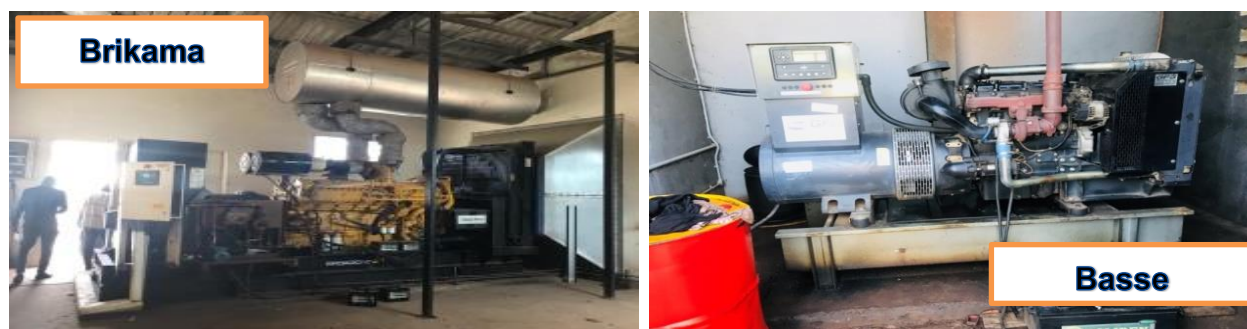
Picture 5: Non- functional Standby Generators at Brikama and Basse water treatment plant.

According to the Water Division management, NAWEC has failed to repair its generators due to financial constraints. However, the audit team was not provided with any document to back this claim.

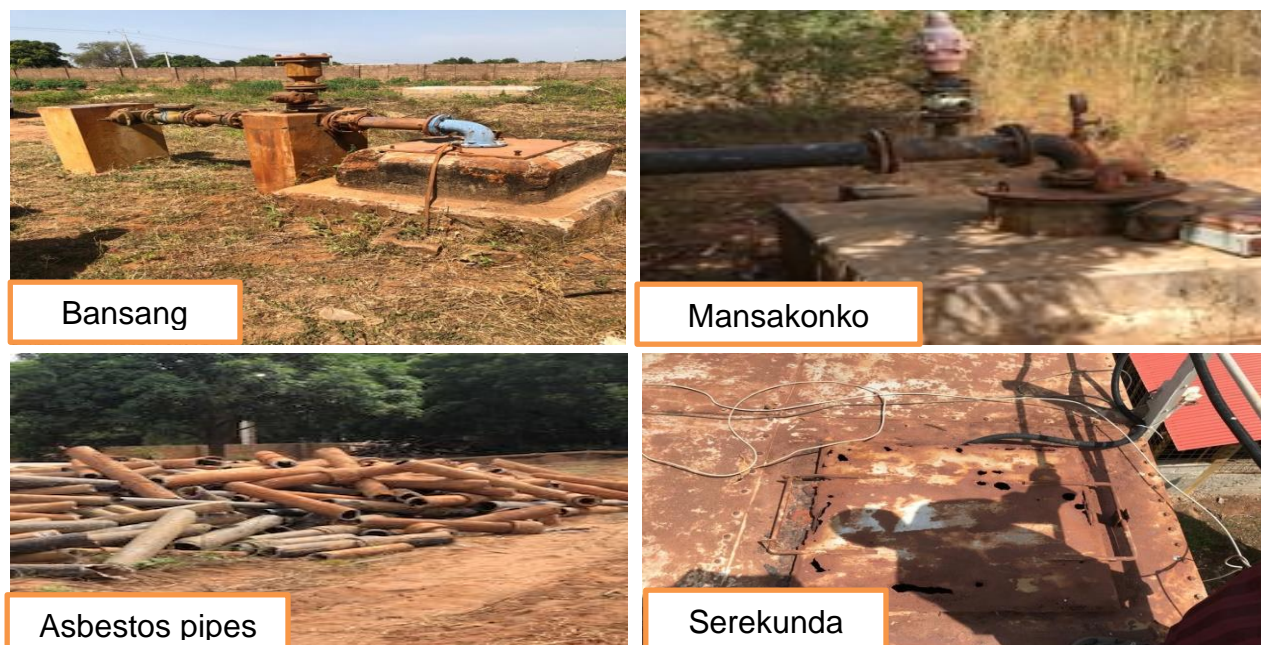
Picture 6: Corroded boreholes at Bansang water facility (top left) and Mansakonko (top right), some of the replaced asbestos pipes placed at Faraja water treatment plant and reservoir at Serekunda water treatment plant (bottom right)

This was due to the company's failure to establish strategies for replacing old infrastructures. Corroded aged infrastructures pose a high risk of failure, resulting in service interruptions and water quality with a bad taste, colour and contamination. **Appendix 8:** Showing 74 boreholes and their ages their ages.

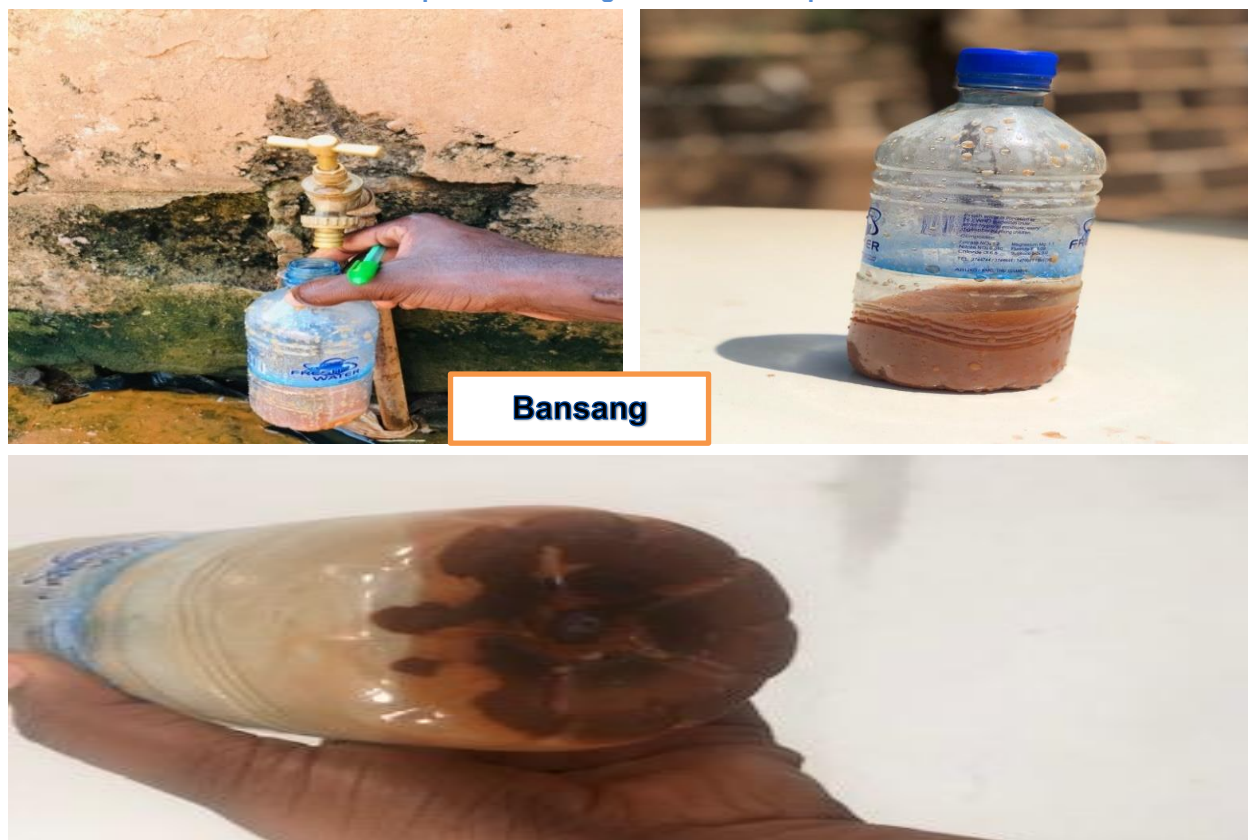
During the inspection of the Bansang Water Treatment Plant, the audit team collected a water sample from a tap inside the Treatment Plant as shown in Picture 7.

Picture 7: Water obtained from the tap in the Bansang water treatment plant

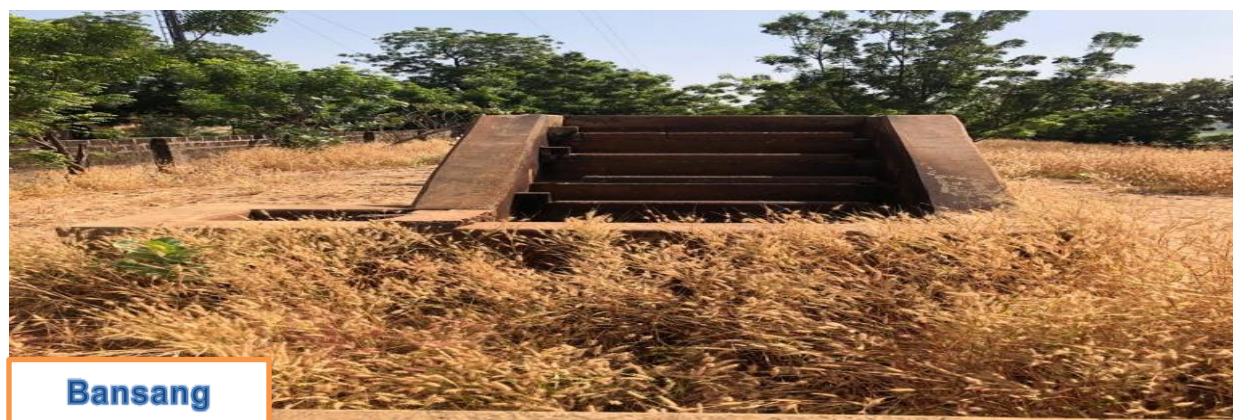
Review of DWR Quarterly Water Quality Monitoring Report revealed that in the third Quarter of 2018, the Bansang water PH level was calculated at 6.57 and this was when aeration was already carried out. However, it was calculated at 5.89 during the second quarter of 2021 when no aeration was carried out during the period. The picture below shows the abandoned aerator at the Bansang Water Treatment Plant.

Picture 8: Abandoned aerator at Bansang Water Treatment Pant

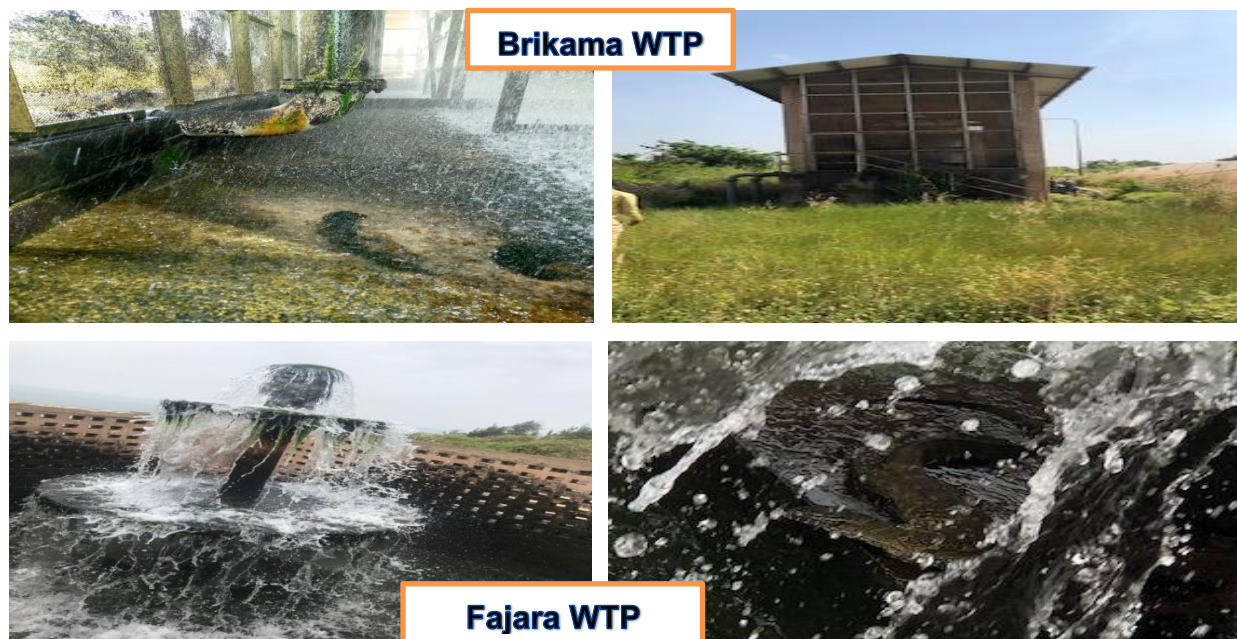
The unhygienic condition of the water facilities poses a high risk to the health of the consumers as the water is exposed to contaminants such as disease-causing microbes (bacteria). Exposed and unenclosed aerators attract birds, animals, reptiles, harmful objects, and bacteria; these can lead to water contamination and a high risk of supplying contaminated water to the population.

Picture 9: Condition of the aerator at Brikama Water Treatment Plant (Top left and top Right) and aerator condition at Fajara Water Treatment Plant showing a reptile (Monitor Lizard) inside the aerator.

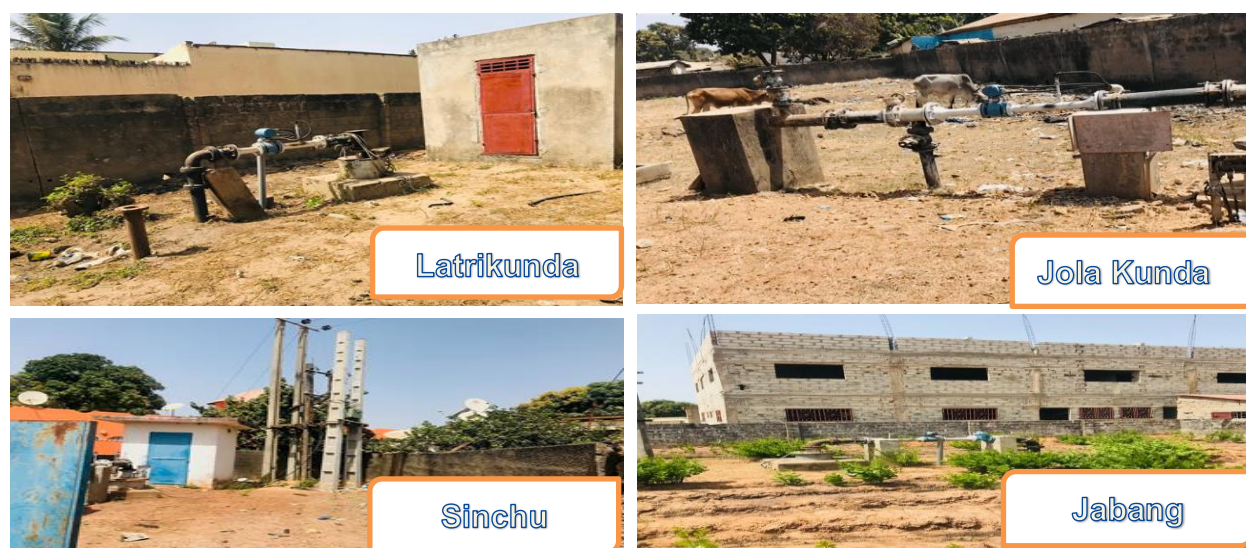
Picture 10: NAWEC boreholes encroached by settlements (Top left PN6(Sinchu), Top right BH12 (Jola Kunda) and BH 18(Latrikunda) all link to the Serekunda WTP and down right is SS6 of Sukuta WTP.
